COMBUSTION FLAME VISUAL INSPECTION

Combustion Flame Visual Inspection

- The following presentation is an overview of a combustion flame analysis for plant personnel for the inspection of the combustion flame for performance
- The combustion testing and adjustments should always be done with the use of combustion analyzer
- However, a daily visual inspection provides an insight into the combustion performance

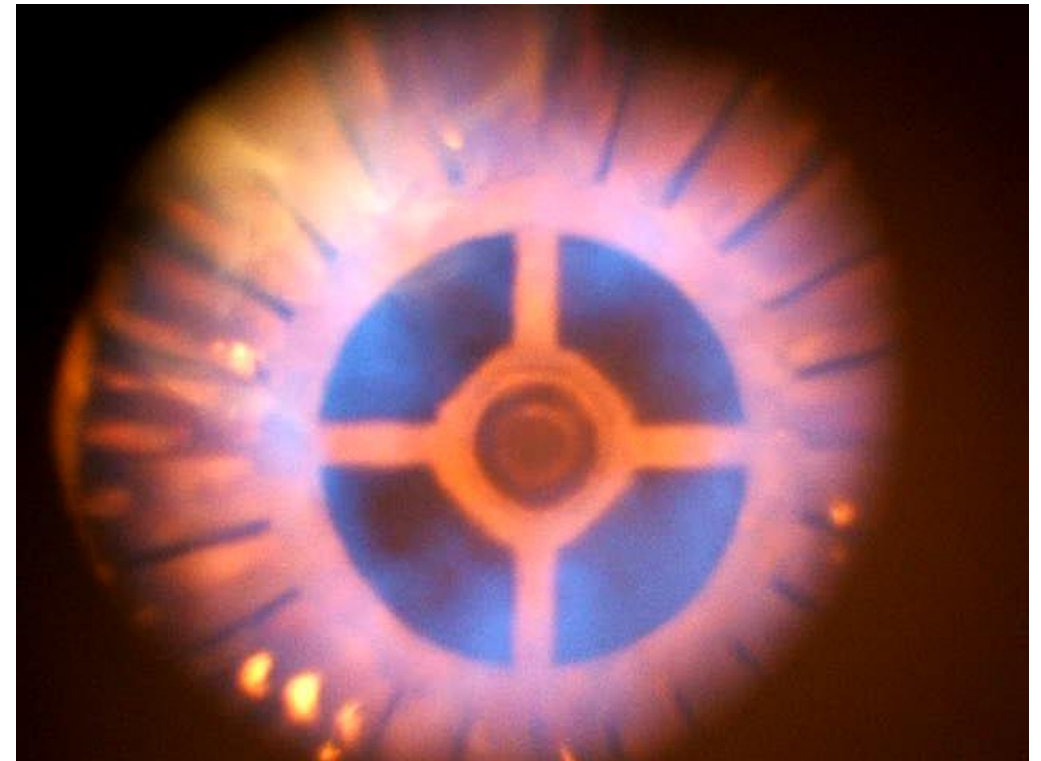
What is a Good Flame Geometry

- › Burner throat has a bright red/yellow color (indicating a high temperature) that is distributed through out the burner throat
- › No dark spots in the burner throat area
- › Flame front is in the correct position

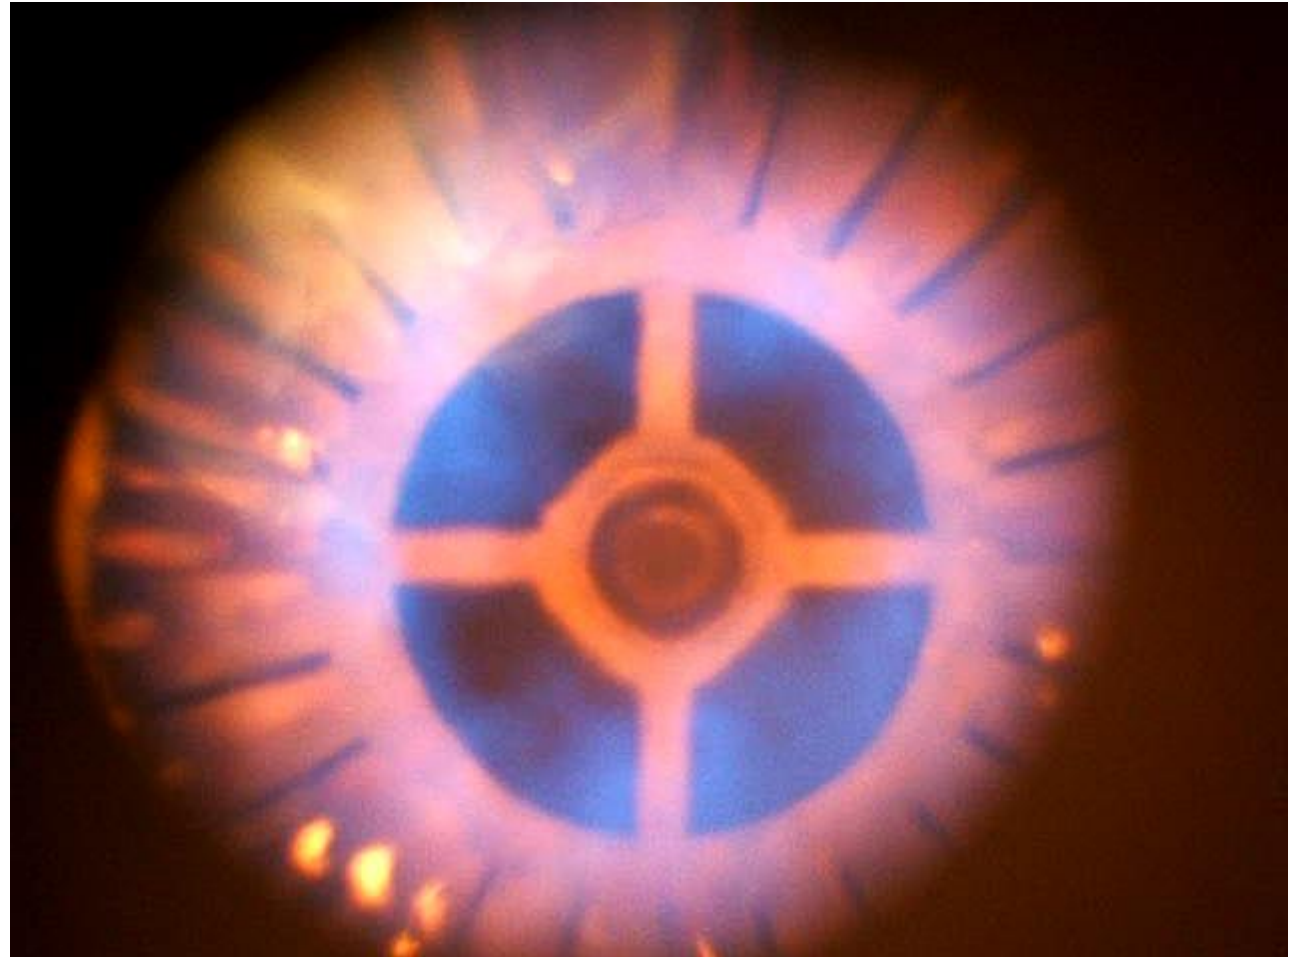
A Good Flame Pattern

- › The flame has a swirl to the operation which is mixing the fuel with the air
- › End Result:
 - Low excess air
 - No carbon monoxide
 - Higher boiler efficiency

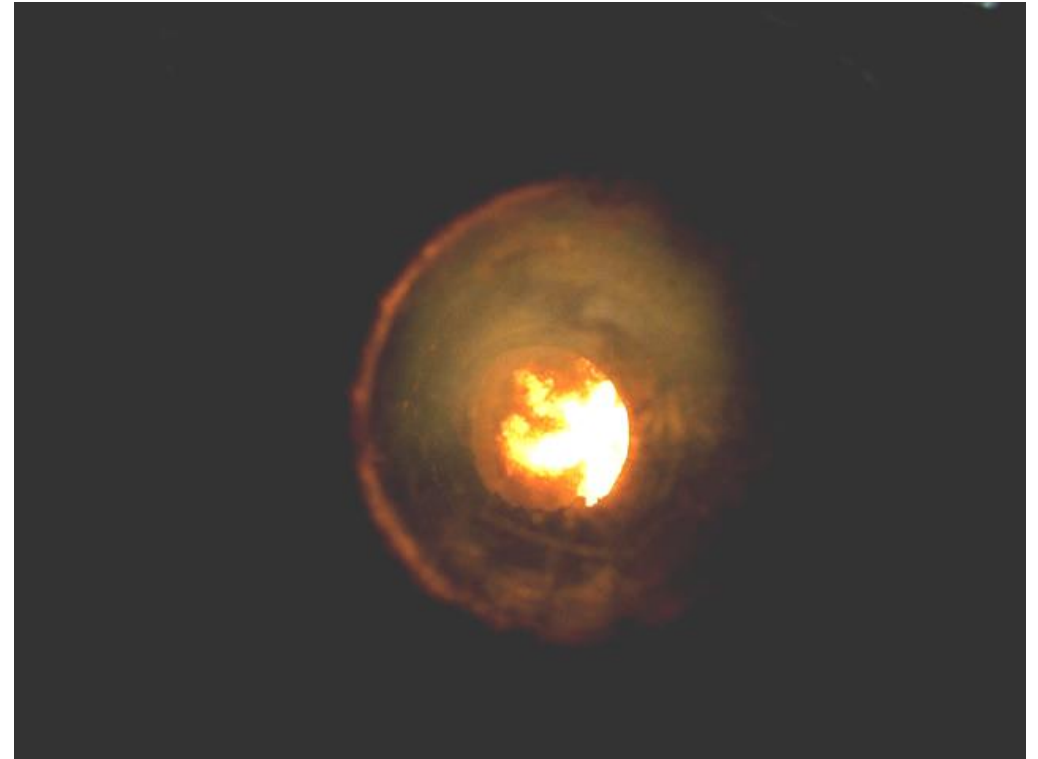
A Imperfect Flame

- › The throat does not have a red/orange glow (high temperature) which is an example of the flame front being too far away from the burner throat
- › The burner throat helps the combustion process by providing temperature to support the combustion process

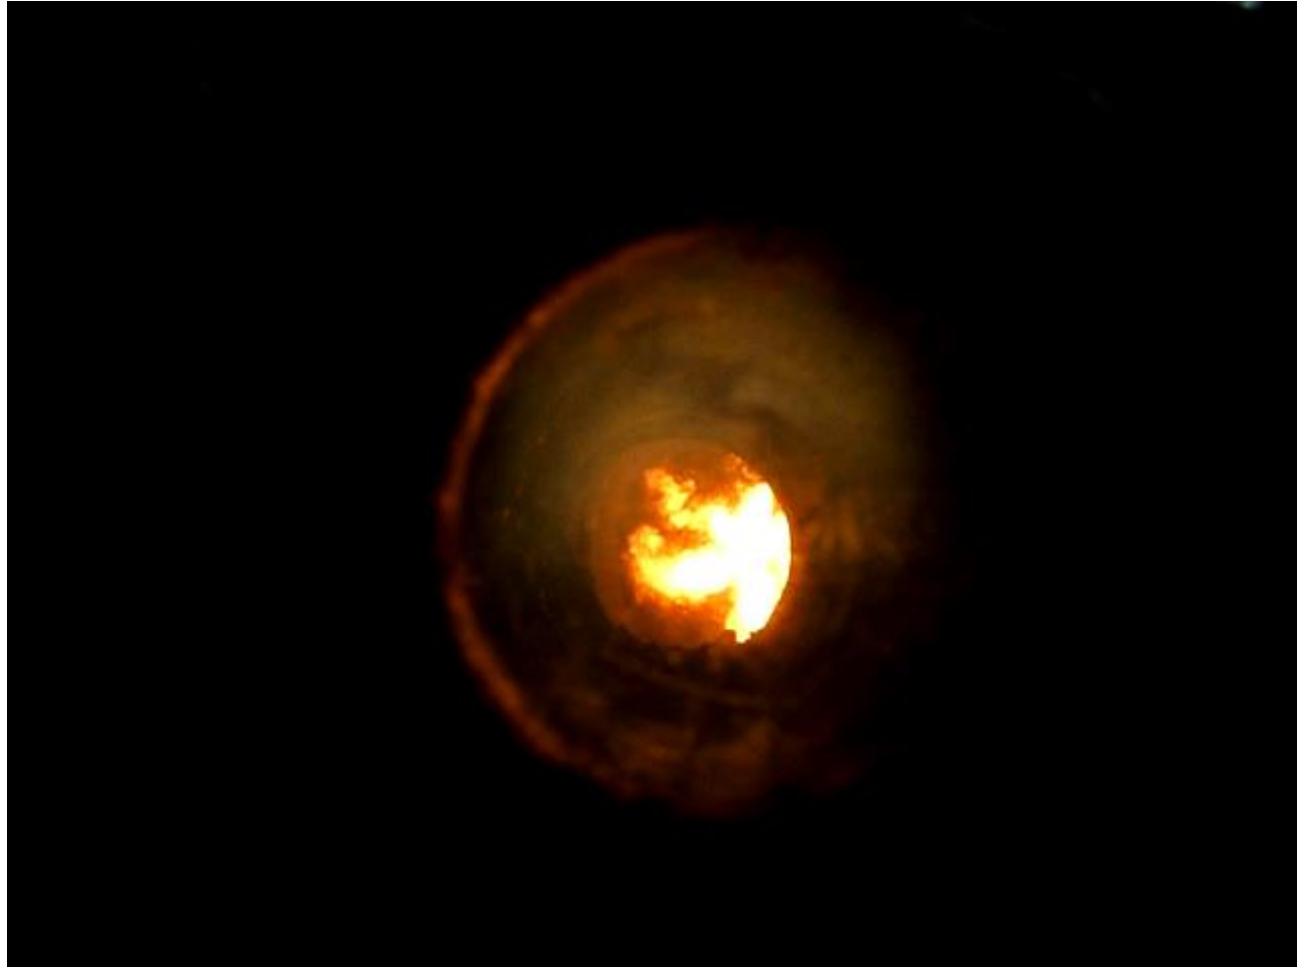
Burner Flame Deficiency

- › Results in high levels of carbon monoxide
- › High levels of excess air

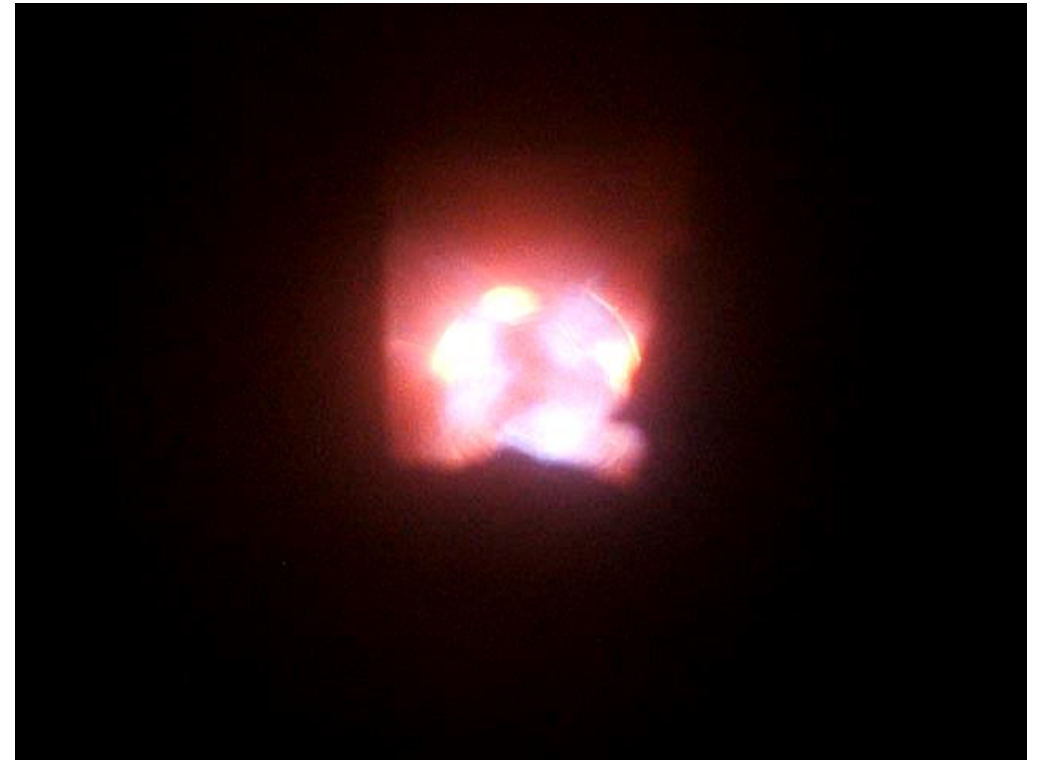
Another Deficient Combustion Flame

- › Burner throat has areas of red/orange, but does not completely cover the entire throat area
- › The results was from poor air flow distribution in the burner
- › Resulting in high levels of carbon monoxide

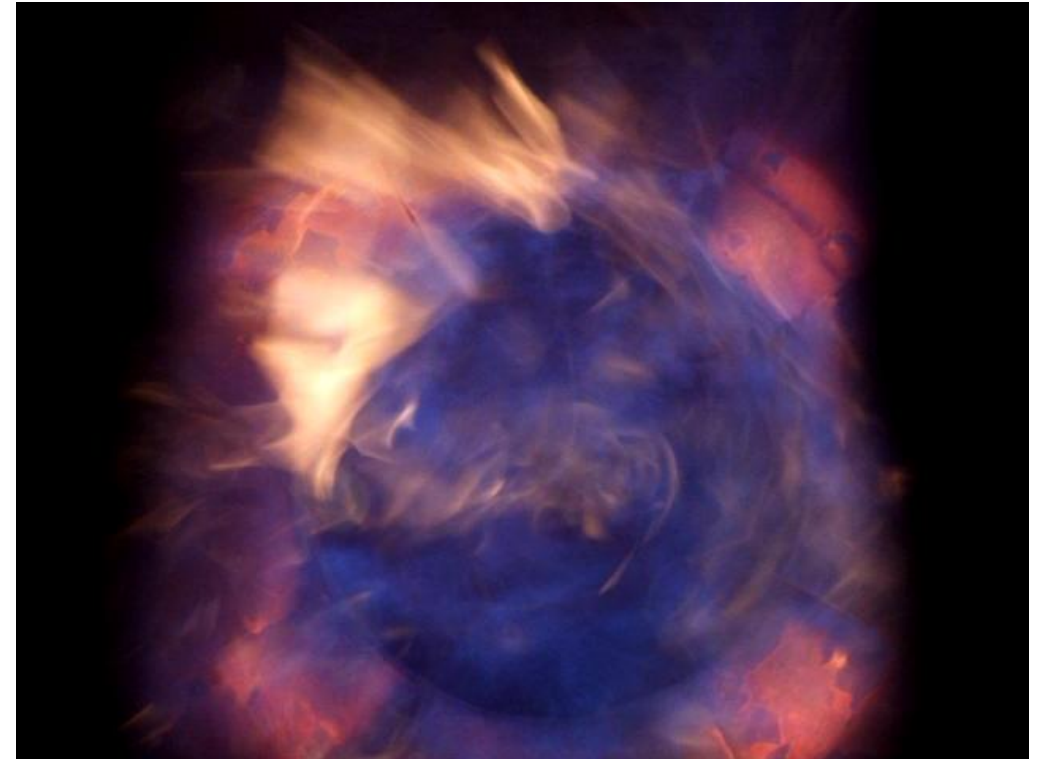
Another Example of Poor Air Flow Mixture

- › Same as the previous slide, the burner is displaying several negative features:
 - Flame front to far away from the burner throat area
 - Air flow mixture is not achieving proper mixture
 - High levels of carbon monoxide
 - High levels of excess air

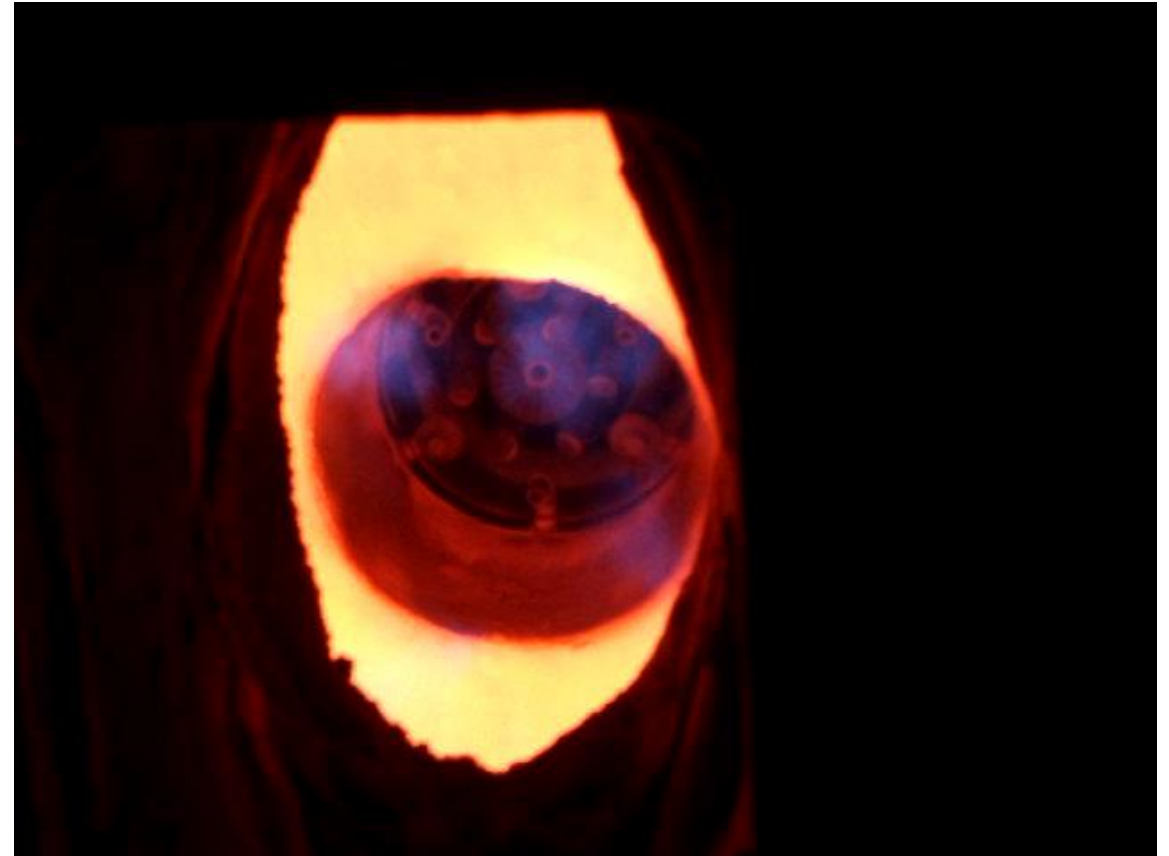
Proper Combustion Flame Operation

- › Throat area totally has the red/orange color which is the result of the following:
 - Proper air and fuel mixing
 - Flame front is in the correct position
 - Resulting in the following:
 - › Low excess air levels
 - › No carbon monoxide in the combustion process

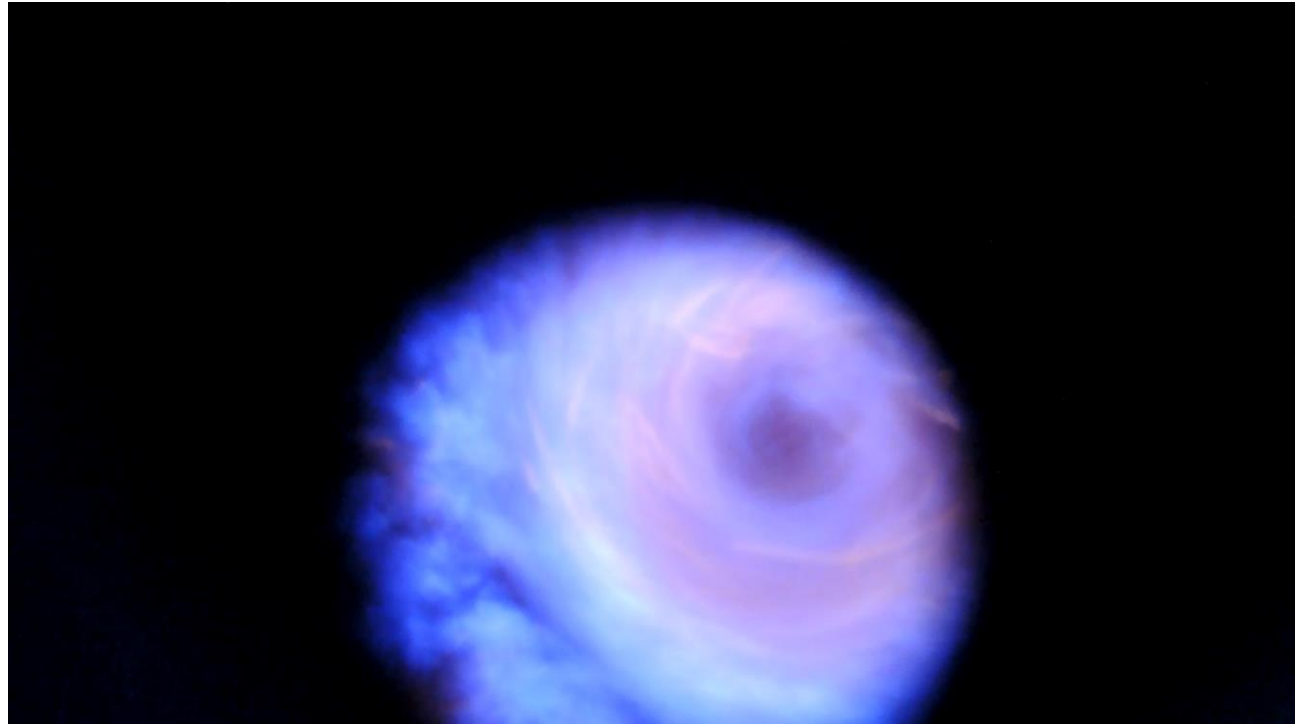
Proper Combustion Operation

- › Burner throat is red/orange (hot) which means flame front is in correct position
- › Proper swirl operation to achieve air/fuel mixing

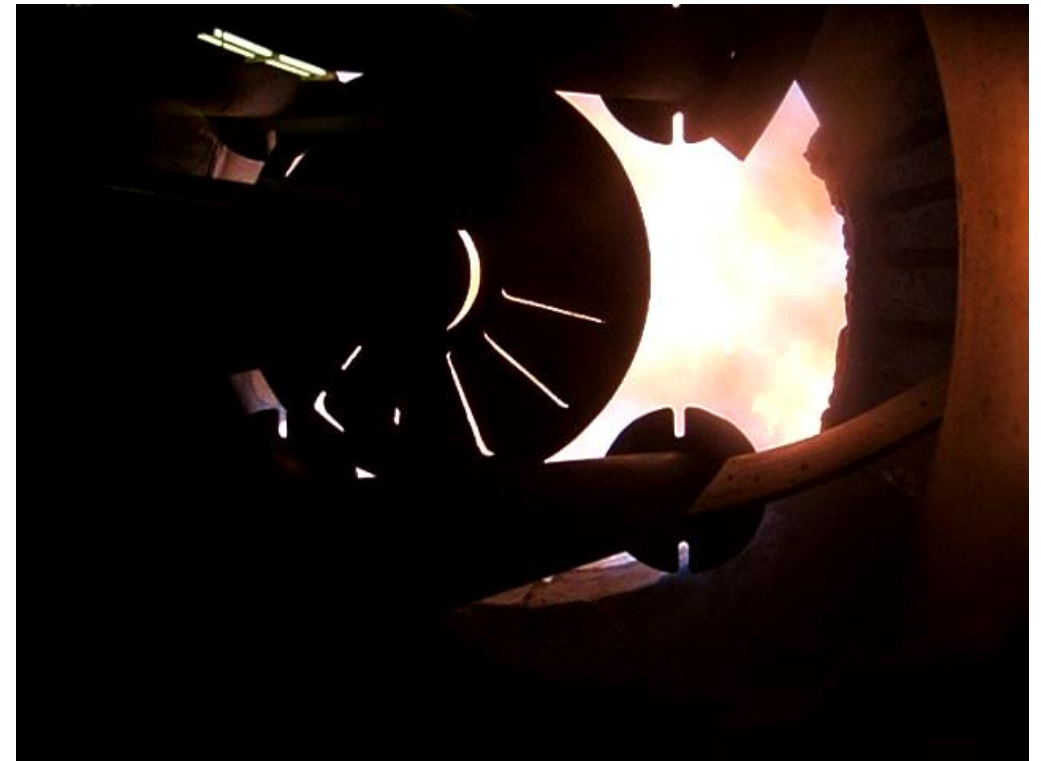
Another View of the Combustion Flame

- › Front view

- More difficult to see the total operation

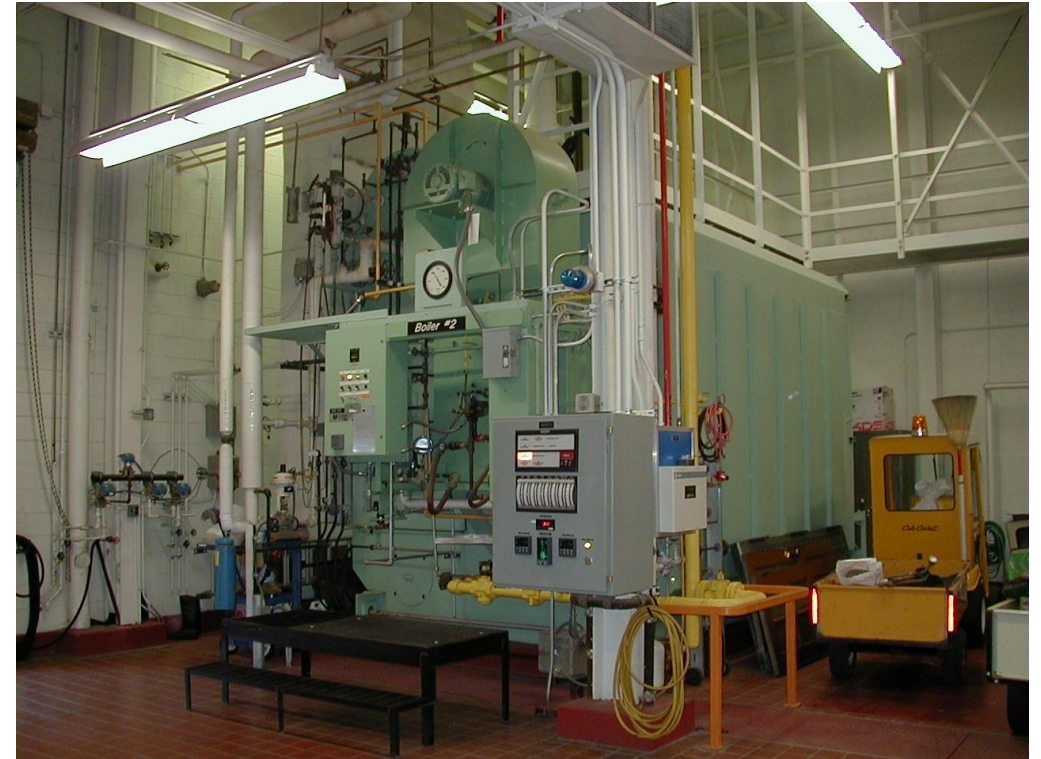
Proper Combustion Efficiency

- › Visual inspection is a key factor in overall boiler efficiency
- › Visual inspection is only one piece of the checking the combustion efficiency
- › Full testing should be performed at least every three months by a qualified person
